## COMMERCIAL WINDSTORM MITIGATION INSPECTION REPORT (OIR-B1-1802)

Lake Heather Heights Condominium Association, Inc  
2340-2347 Lake Heather Heights Ct  
Dunedin , FL 34698

As of 3/27/2014

FPAT File #VAL148221

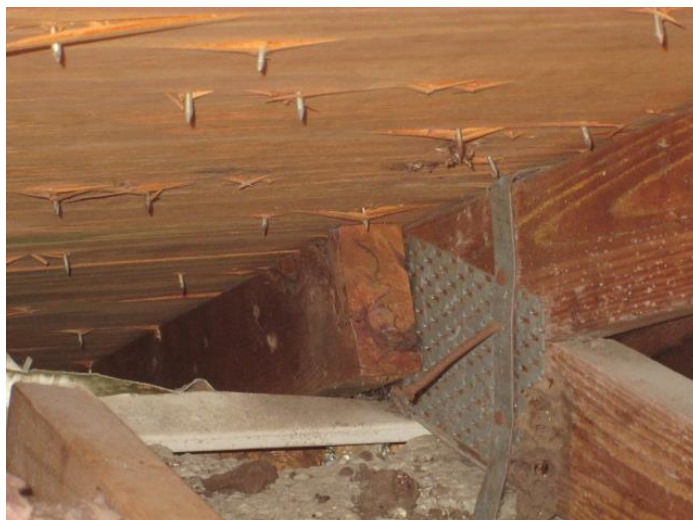
Roof to Wall Attachment

| 4. <b><u>Roof to Wall Attachment:</u></b><br>Comments: | <b>Clips</b><br>Inspection verified embedded straps fastened with a minimum of three nails. |

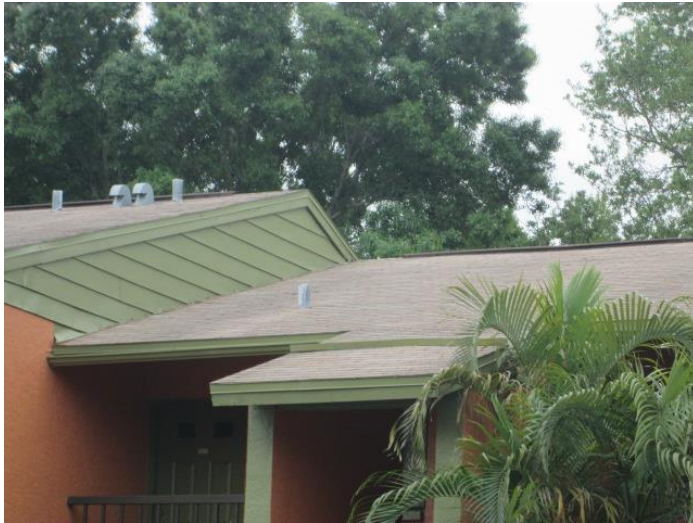
Roof Covering

| 2. <b><u>Roof Covering:</u></b><br>Comments: | <b>FBC Equivalent</b><br>The roof covering was replaced in 2003. The roof permit was confirmed and the permit number is 03-2551. This roof was verified as meeting the building code requirements outlined on the mitigation affidavit. |

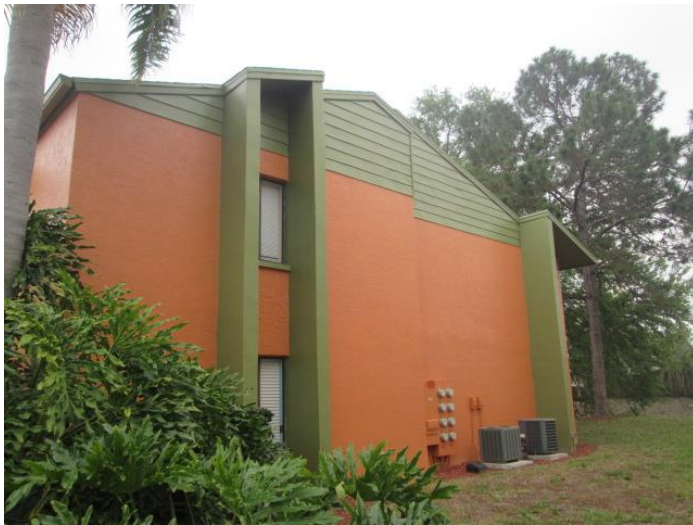
Roof Shape

| 5. <b><u>Roof Geometry:</u></b><br>Comments: | <b>Other Roof</b><br>Inspection verified a gable roof shape. |
