COMMERCIAL WINDSTORM MITIGATION INSPECTION REPORT (OIR-B1-1802)

Lake Heather Heights Condominium Association, Inc
2382-2397 Lake Heather Heights Ct
Dunedin , FL 34698

As of 3/27/2014

RECAPITULATION OF MITIGATION FEATURES
For 2382-2397 Lake Heather Heights Ct

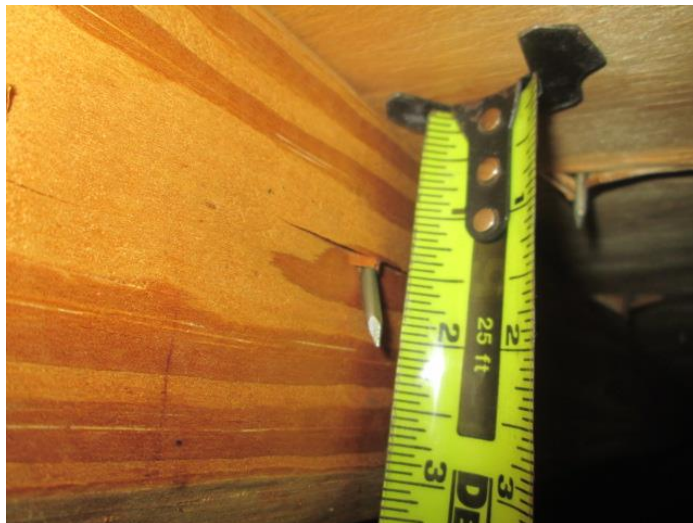
Roof Deck Attachment

3. **Roof Deck Attachment:** **Level C**
Comments: Inspection verified 1/2" plywood roof deck attached with 8d nails at a minimum of 6" on the edge & 6" in the field.

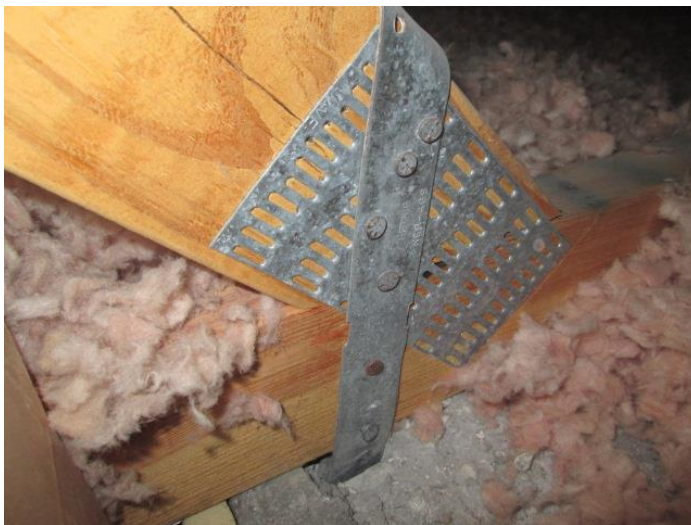
Roof to Wall Attachment

4. **Roof to Wall Attachment:** **Single Wraps**
Comments: Single wraps were verified during our attic inspection as the roof wall connection. Each single wrap has a minimum of two nails on the front of the truss and one nail on the opposite side.

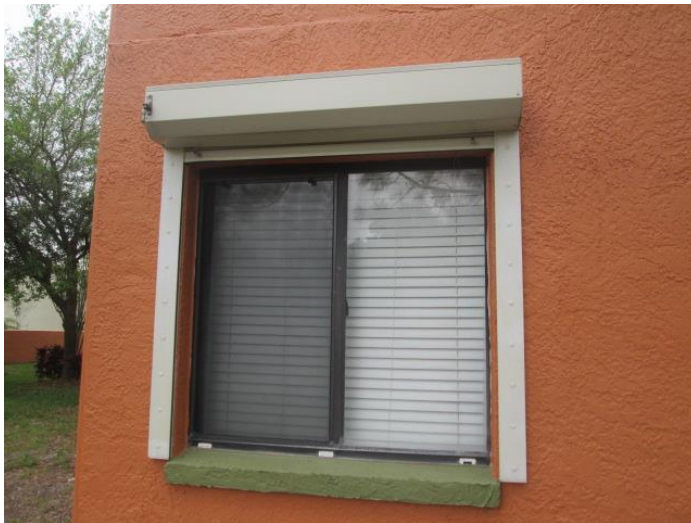
Some Opening Protection

5. **Roof Geometry:** **Other Roof**
Comments: Inspection verified a gable roof shape.
6. **SWR:** **No**
Comments: Inspection verified no SWR.
7. **Opening Protection:** **None or Some Glazed Openings**
Comments: Inspection verified some metal shutters.

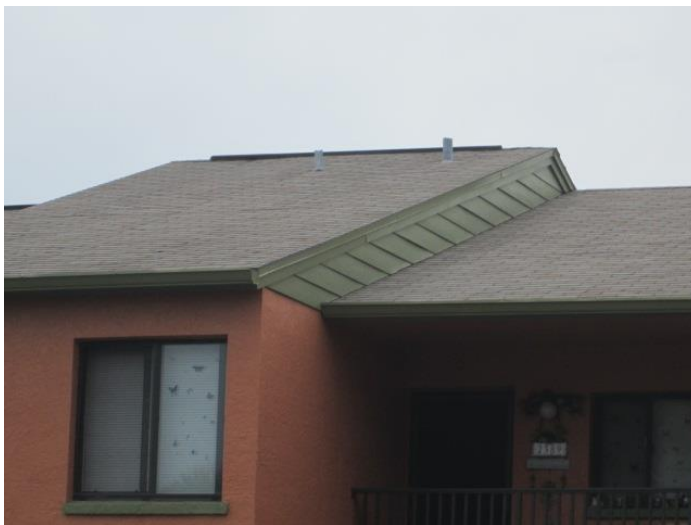
Roof Covering

2. **Roof Covering:** **FBC Equivalent**
Comments: The roof covering is original to the construction of the building in 2002, no permit information was found with the local Building Department. This roof was verified as meeting the requirements outlined on the mitigation affidavit.
